## **Failure of VRLA Batteries: Material Aspects**

<sup>1</sup> Materials Reliability Research Unit, National Metal and Materials Technology Center (MTEC)  
National Science and Technology Development Agency (NSTDA), Pathumthani, Thailand 12120

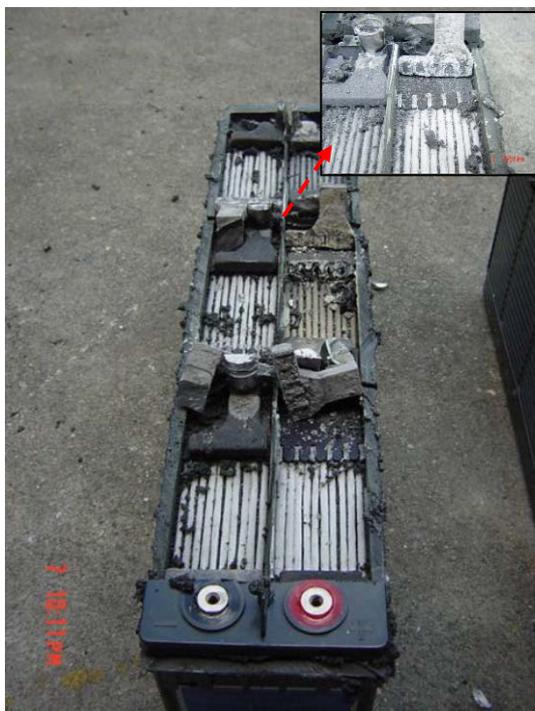
Fig.1 Failed VRLA battery caused by the negative strap corrosion.

After the occurrence of failure, the preliminary investigation was conducted by the distributor to find the separated components in the battery. Fig. 1 shows a failed VRLA battery caused by the negative strap corrosion, which is used for the failure investigation.

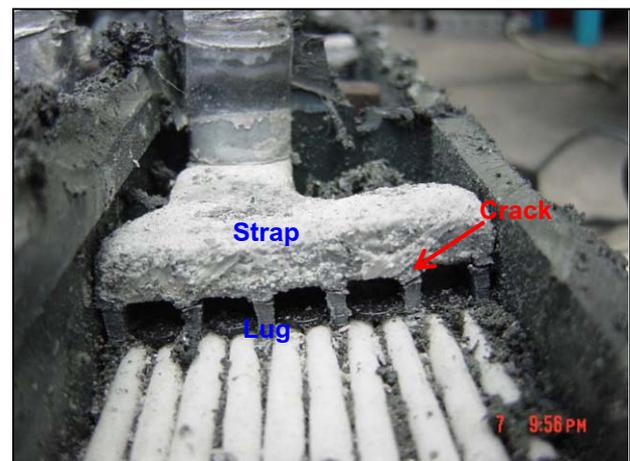
From the visual inspection, it indicated that the negative strap is entirely covered with by white corrosion products. In addition, a crack is found at the interface, joined line, between the strap and lug as shown in Fig.2.

Fig.2 White corrosion products and a crack occurring on the negative strap.

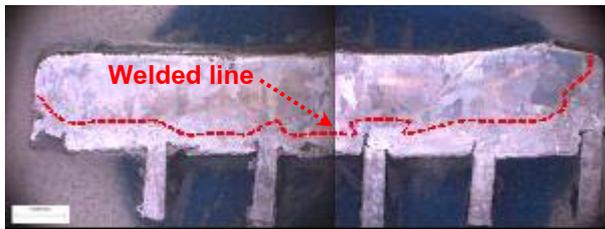
As shown in Fig. 3, the lower area of strap adjacent to the lug has a relatively small grain size with respects to the upper areas. Moreover, more severe corrosion is obtained for

the areas showing the fine-grain structure, causing the obvious separation between the strap and lug.

Fig. 3 Macrostructure of the failed negative strap.

From the macrostructure examination of the failed battery, it was found that the serious damage occurred at the weld line of battery, area where the melting between strap (lead-tin alloy) and lug (lead-calcium alloy), especially, the interface area between strap and lug. When examining the grain orientation at the joint between strap and lug, grains were found oriented along the direction of heat transfer. This grain orientation reduces the interfacial strength between strap and lug and increases the risk of intergranular corrosion [1-3].

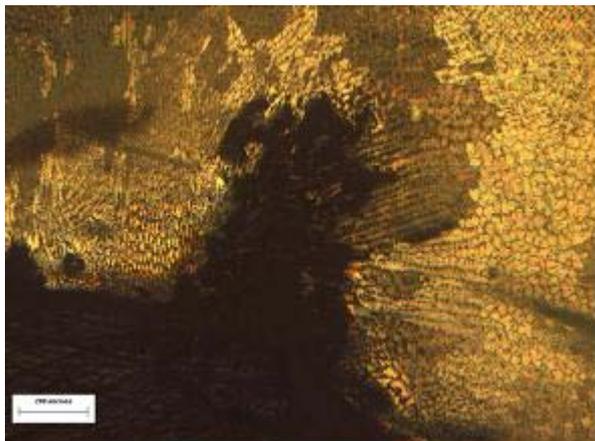
Fig. 4 shows the microstructure of the strap at the area adjacent to the completely separated lug. It can be seen that this region has the relatively small grain size with respects to the other regions. The elongated shape of grain structure along the heat transfer direction is obtained for that region.

Fig. 4 The microstructure of the strap at the point of separation from the lug

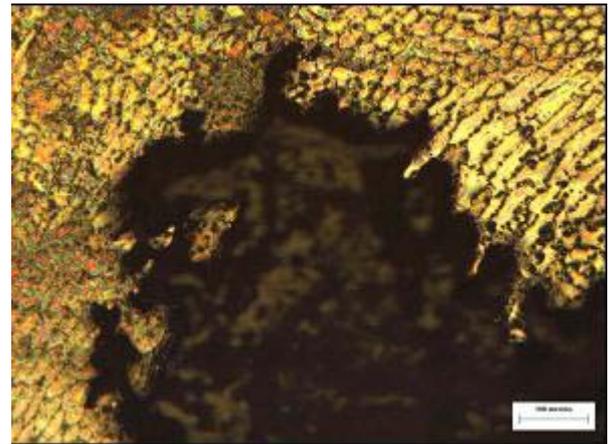
At the joint between strap and lug, intermetallic compounds and intergranular corrosion are observed in large area as shown in Fig. 5. Furthermore, corrosion normally propagated from the external surface of the joint between strap and lug as shown in Fig. 6.

Fig. 5 Microstructure at the joint between strap and lug

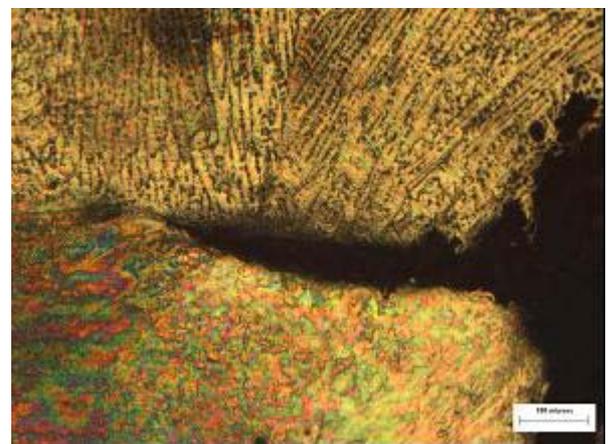
Fig. 6 The propagation of corrosion at the joint between strap and lug

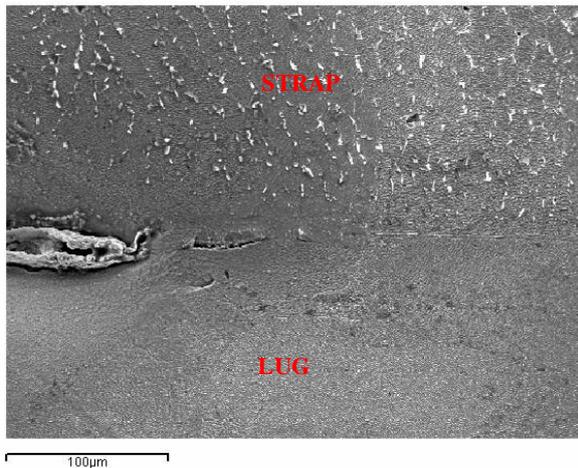
Surface analysis by SEM can confirm that the damage was initiated at the interfacial area between strap and lug, moreover, intermetallic compound were found precipitating along grain boundaries in the strap (Fig.7).

Fig. 7 SEM micrograph of the interfacial area between strap and lug.

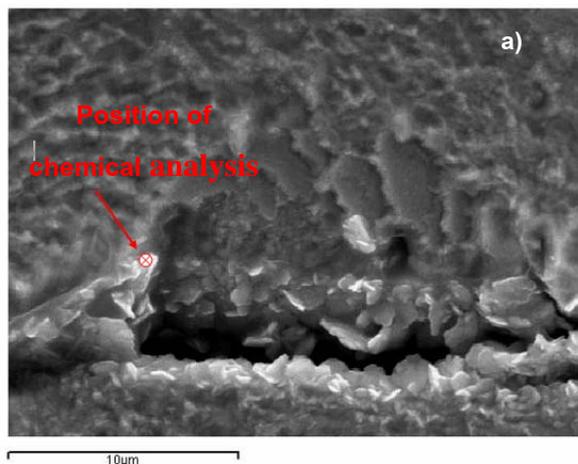
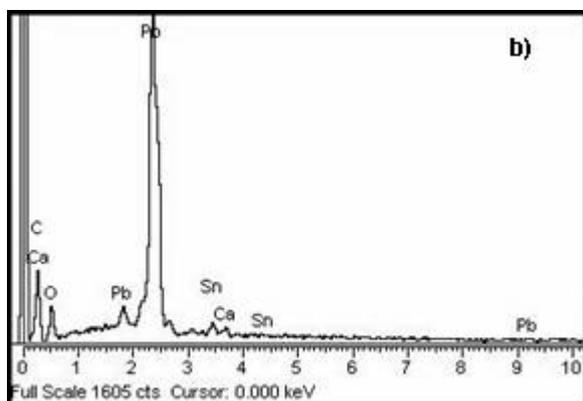
Investigation of the crack at high magnification shows precipitation of intermetallic compound at the edge and within the crack as shown in Fig. 8a. Chemical analysis by EDS (Fig. 8b) shows that the particles consist of carbon (C), oxygen (O), lead (Pb), tin (Sn) and calcium (Ca). On the other hand, Chemical analysis of intermetallic compounds at grain boundary of

Fig.8 a) SEM micrograph of the crack and the position of chemical analysis. b) EDS spectrum

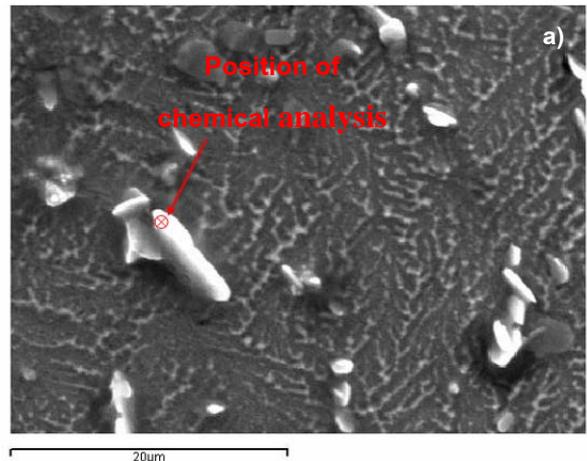
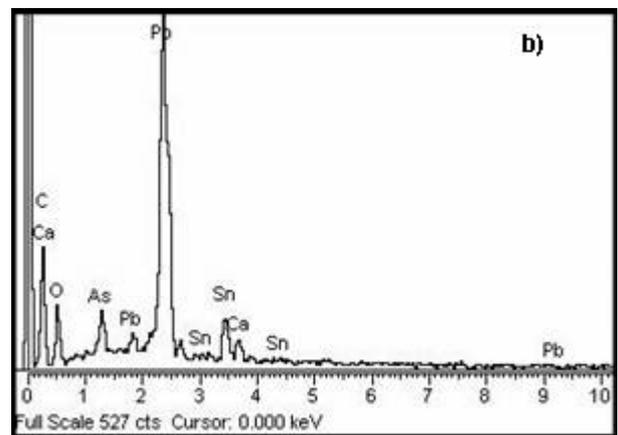
strap shows that they consist of carbon (C), oxygen (O), lead (Pb), tin (Sn), calcium (Ca) and arsenic (As) as shown in Fig. 9

Fig.9 a) SEM micrograph of the intermetallic compound at grain boundaries and the position of chemical analysis. b) EDS spectrum

Examination of microstructure of the damaged strap and lug showed that the interface between strap and lug was the initiation site of corrosion in intergranular mode. Fine intermetallic compounds were found in the intergranularly corroded area. Chemical analysis shows that the precipitates consist of the following contaminating elements, tin (Sn), calcium (Ca) and arsenic (As) (additive for grain refinement). Precipitation might result from the mixing of molten strap and lug. This mixing decreases the solubility of calcium in lead alloys [2, 4-6]. In addition, lead, tin and calcium might react with one another to form intermetallic compounds that precipitated along grain boundaries [2]. Moreover, calcium dissolved in lead alloys reduces the intergranular corrosion resistance of lead alloys. According to those reasons, the tin content of strap should be lower than 0.75 wt.% [1].
